What is Wrong with this Picture?
Confined Space Safety – Plant

What is Wrong with this Picture?
Confined Space Plant – Answer Key

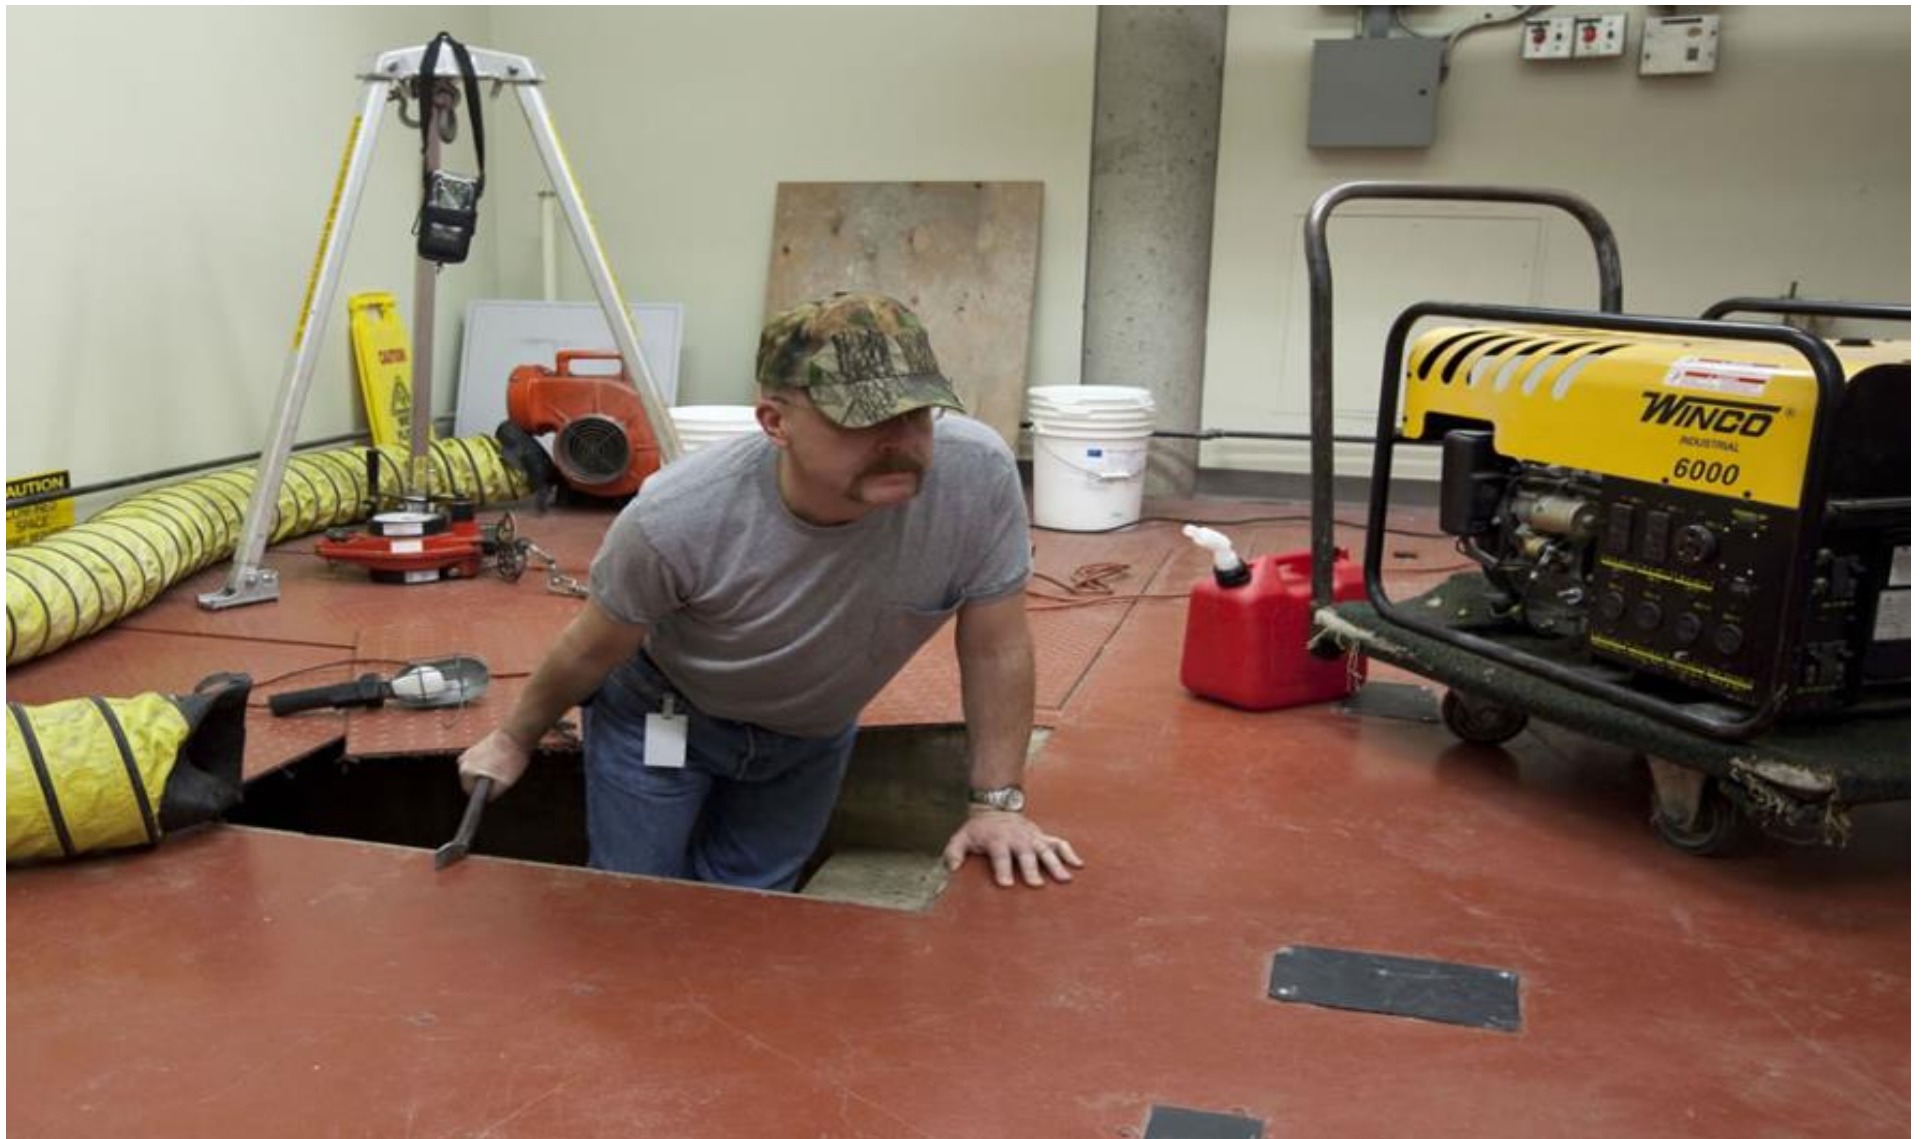
- No confined space paperwork (permit) is visible in the photo (the yellow sign says permit required)

- The ventilation hose is not inserted into the confined space

- The monitoring device is on the tripod
- The tripod is not ready for use

- The winch is lying on the floor

- The “trouble light” is not vapor-proof (commonly referred to as “explosion-proof”)

- The ventilation hose is not attached to the blower

- The worker has no personal protective equipment (it is possible that none are required)

- The five-gallon paint can is open

- The gasoline is waiting to be kicked over

- The gasoline-powered generator is placed in a small room
